# **OLMSTED ENVIRONMENTAL SERVICES, INC.**

Date: February 6, 2021

Prepared by : Ed Olmsted, CIH, CSP

Subject: **Ventilation System Screening**  
**School 46 – Charles Carroll School, 250 Newcastle Road, Rochester, NY**

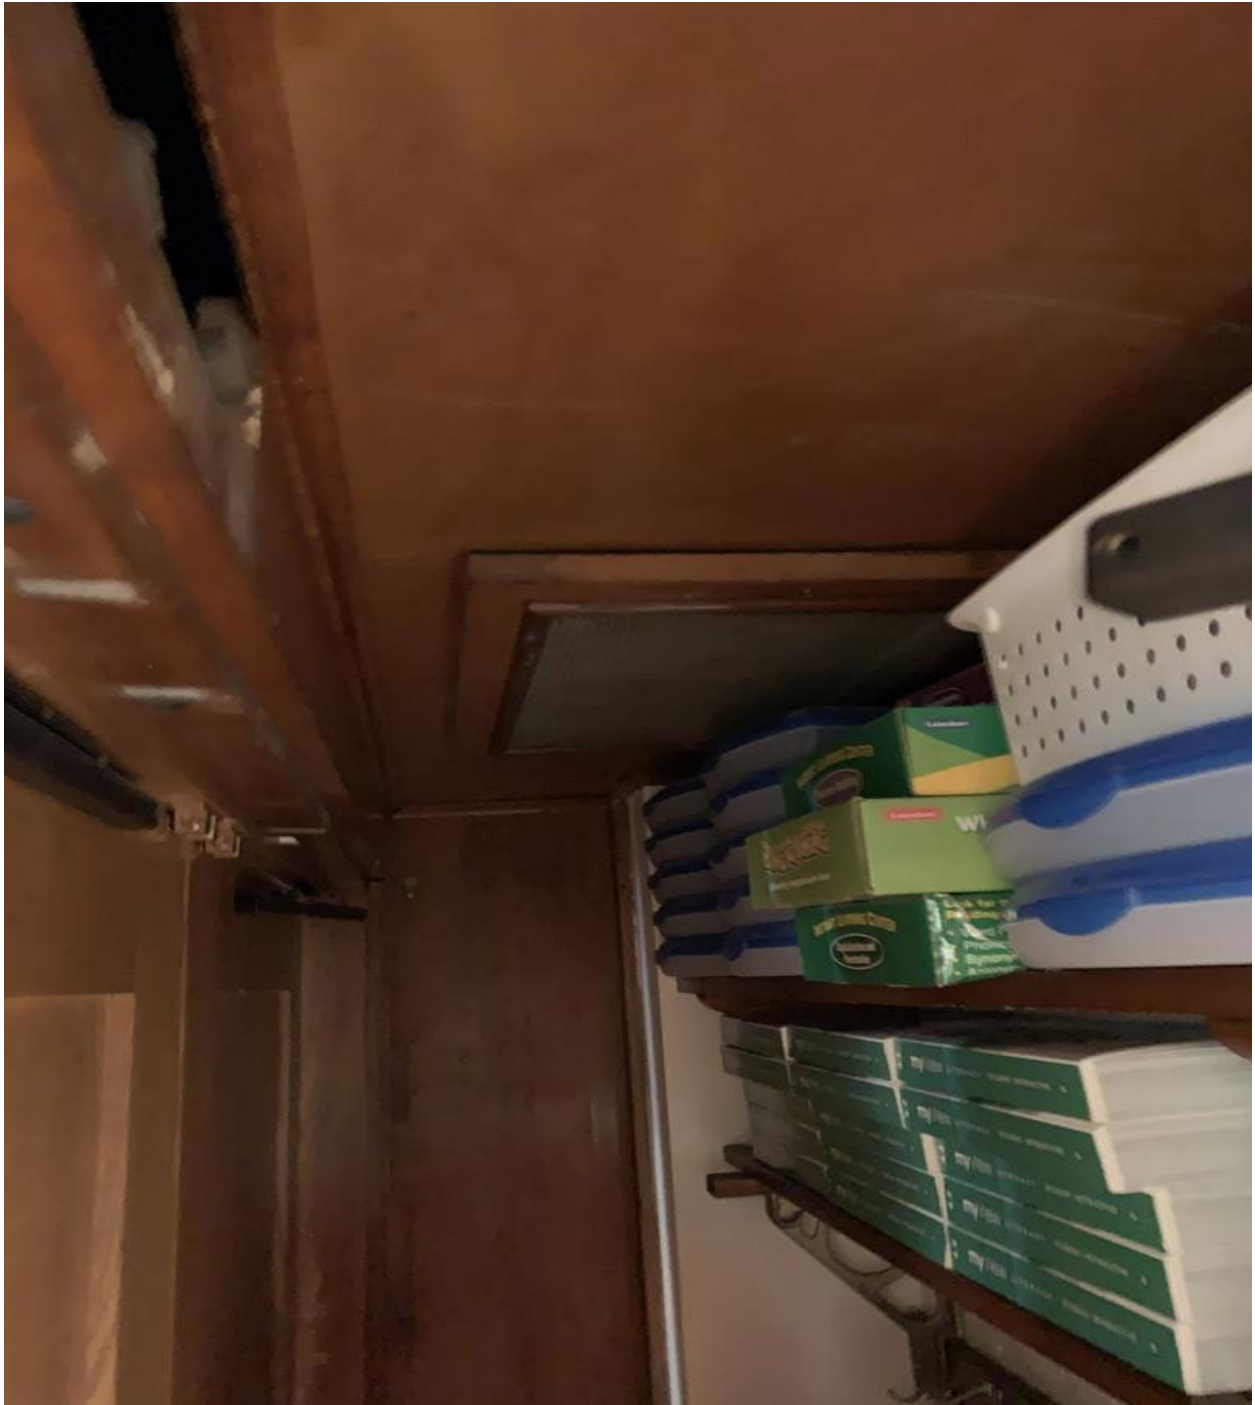
2. There are exhaust fans on the roof that pull air from the bathrooms. Each classroom has operable windows that can be opened for outside air. There are gravity (passive) vents in the coat closets in each classroom that allow for natural exhaust of air to the roof. Air flows to the roof from the classrooms by stack effect and thermal effects and also to relieve pressure from the univent mechanical supply of outside air.

Exhaust in the closets

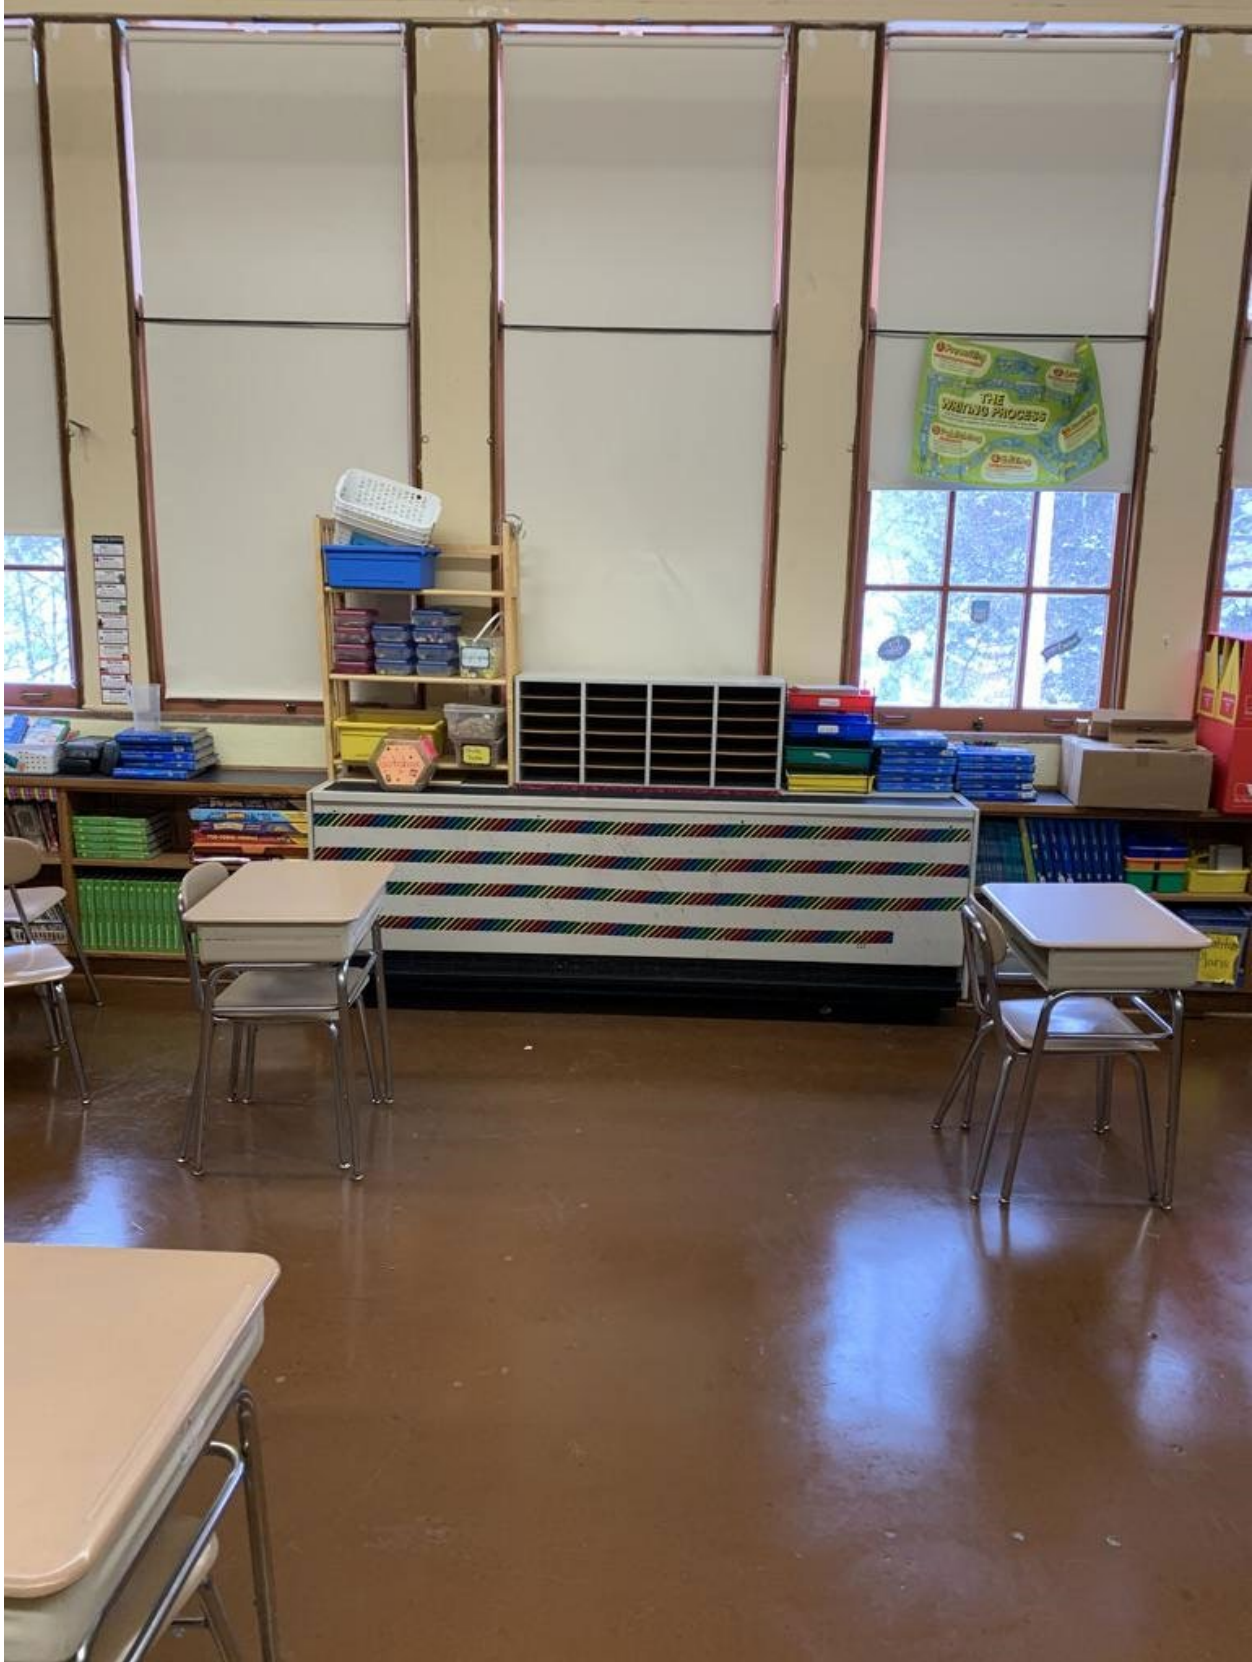
8. Room 209 The univent was working in this room. The exhaust ventilation is working. The windows are operable.
9. Room 200 Art Room – There are two exhaust vents in this room that are not pulling air. These exhausts are on the fan in the attic that is in the process of repair. The univent is working properly but there are many plastic storage bins stored on the unit. This can block flow.

Operable windows and univents – prevent blocking of the vent with stored materials

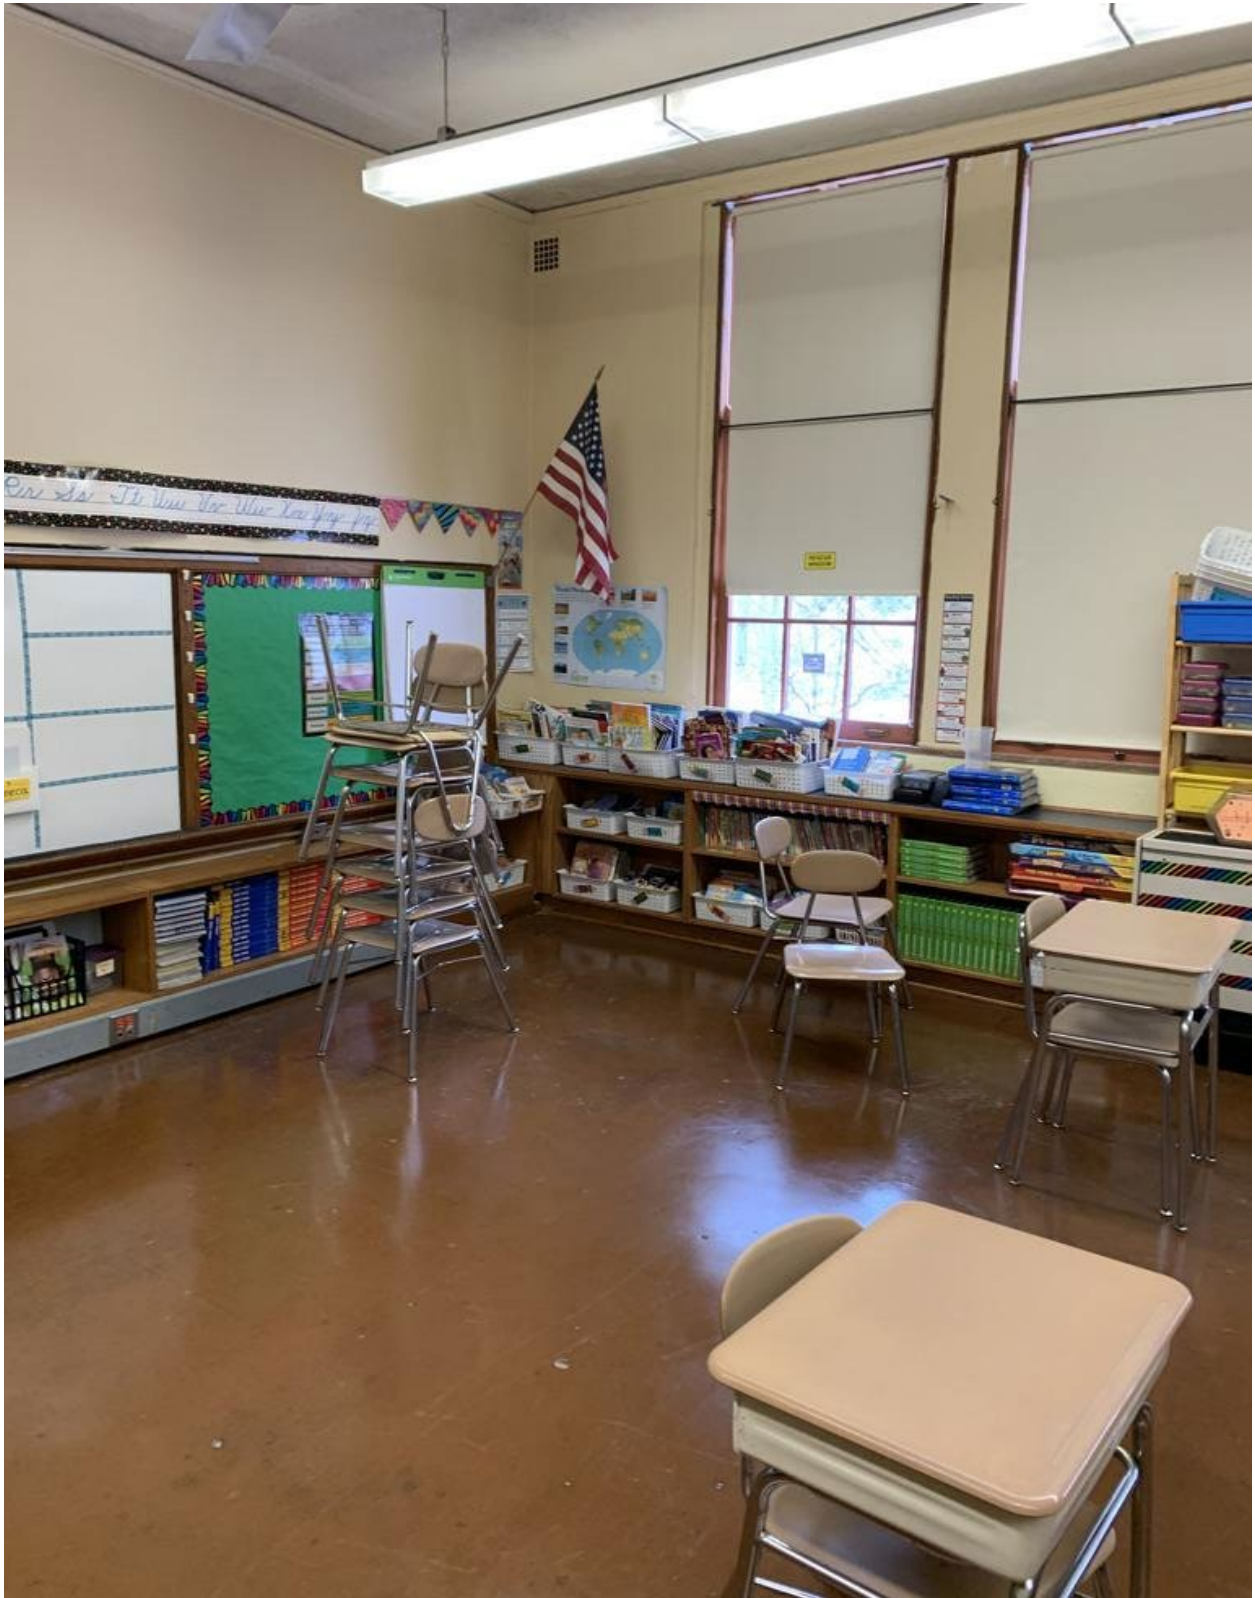
Exhaust vents are also in the upper corners of most rooms
