OLMSTED ENVIRONMENTAL SERVICES, INC.

Date: February 6, 2021

Subject: **Ventilation System Screening**
School 34 – Dr. Louis Cerulli School, 530 Lexington Avenue, Rochester, NY

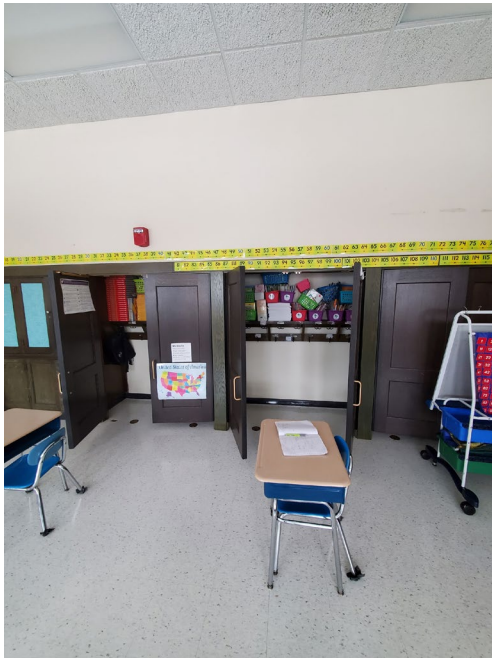
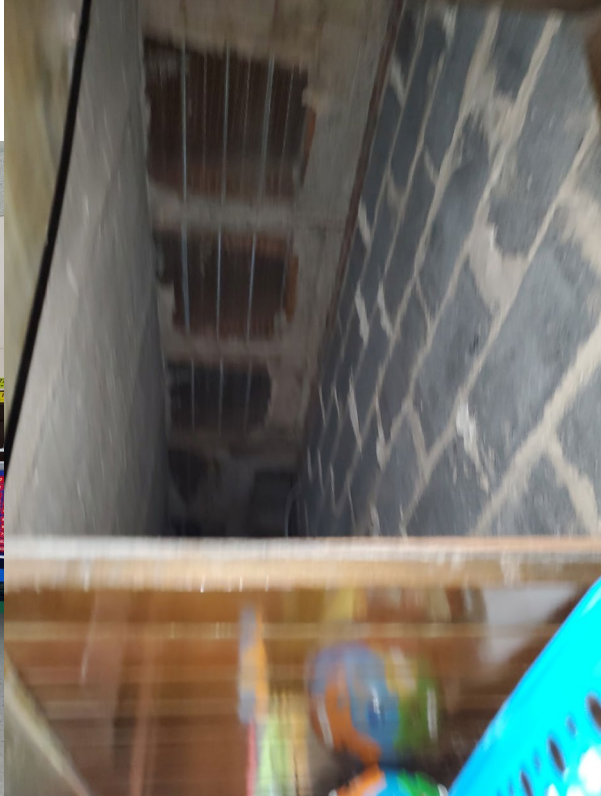
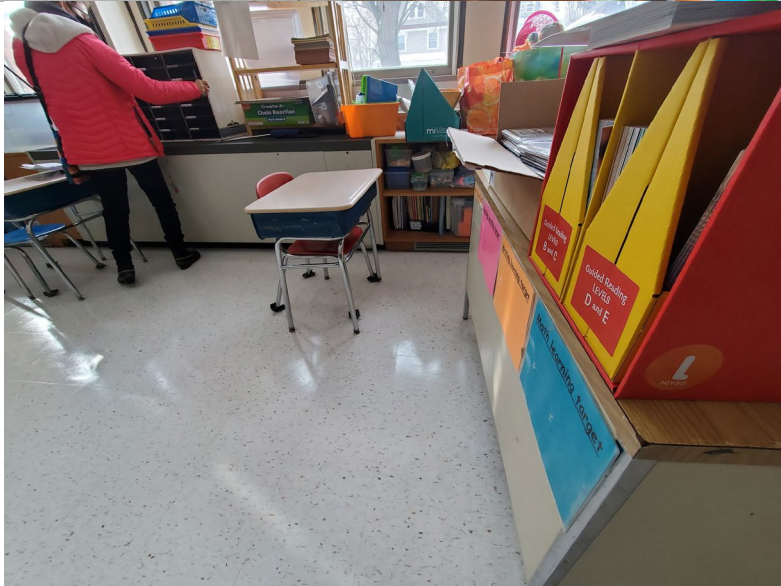
Typical ventilation scheme in the school. A passive return located in the closet with an univent under operable windows.
