**ROCHESTER SCHOOLS MODERNIZATION
PROGRAM PHASE III**

Franklin Educational Campus (Project # 101-041)

ADDENDUM #2

**Attachment 1: Thermal Radiation
Survey of Franklin Educational
Campus Roof - August 2023**

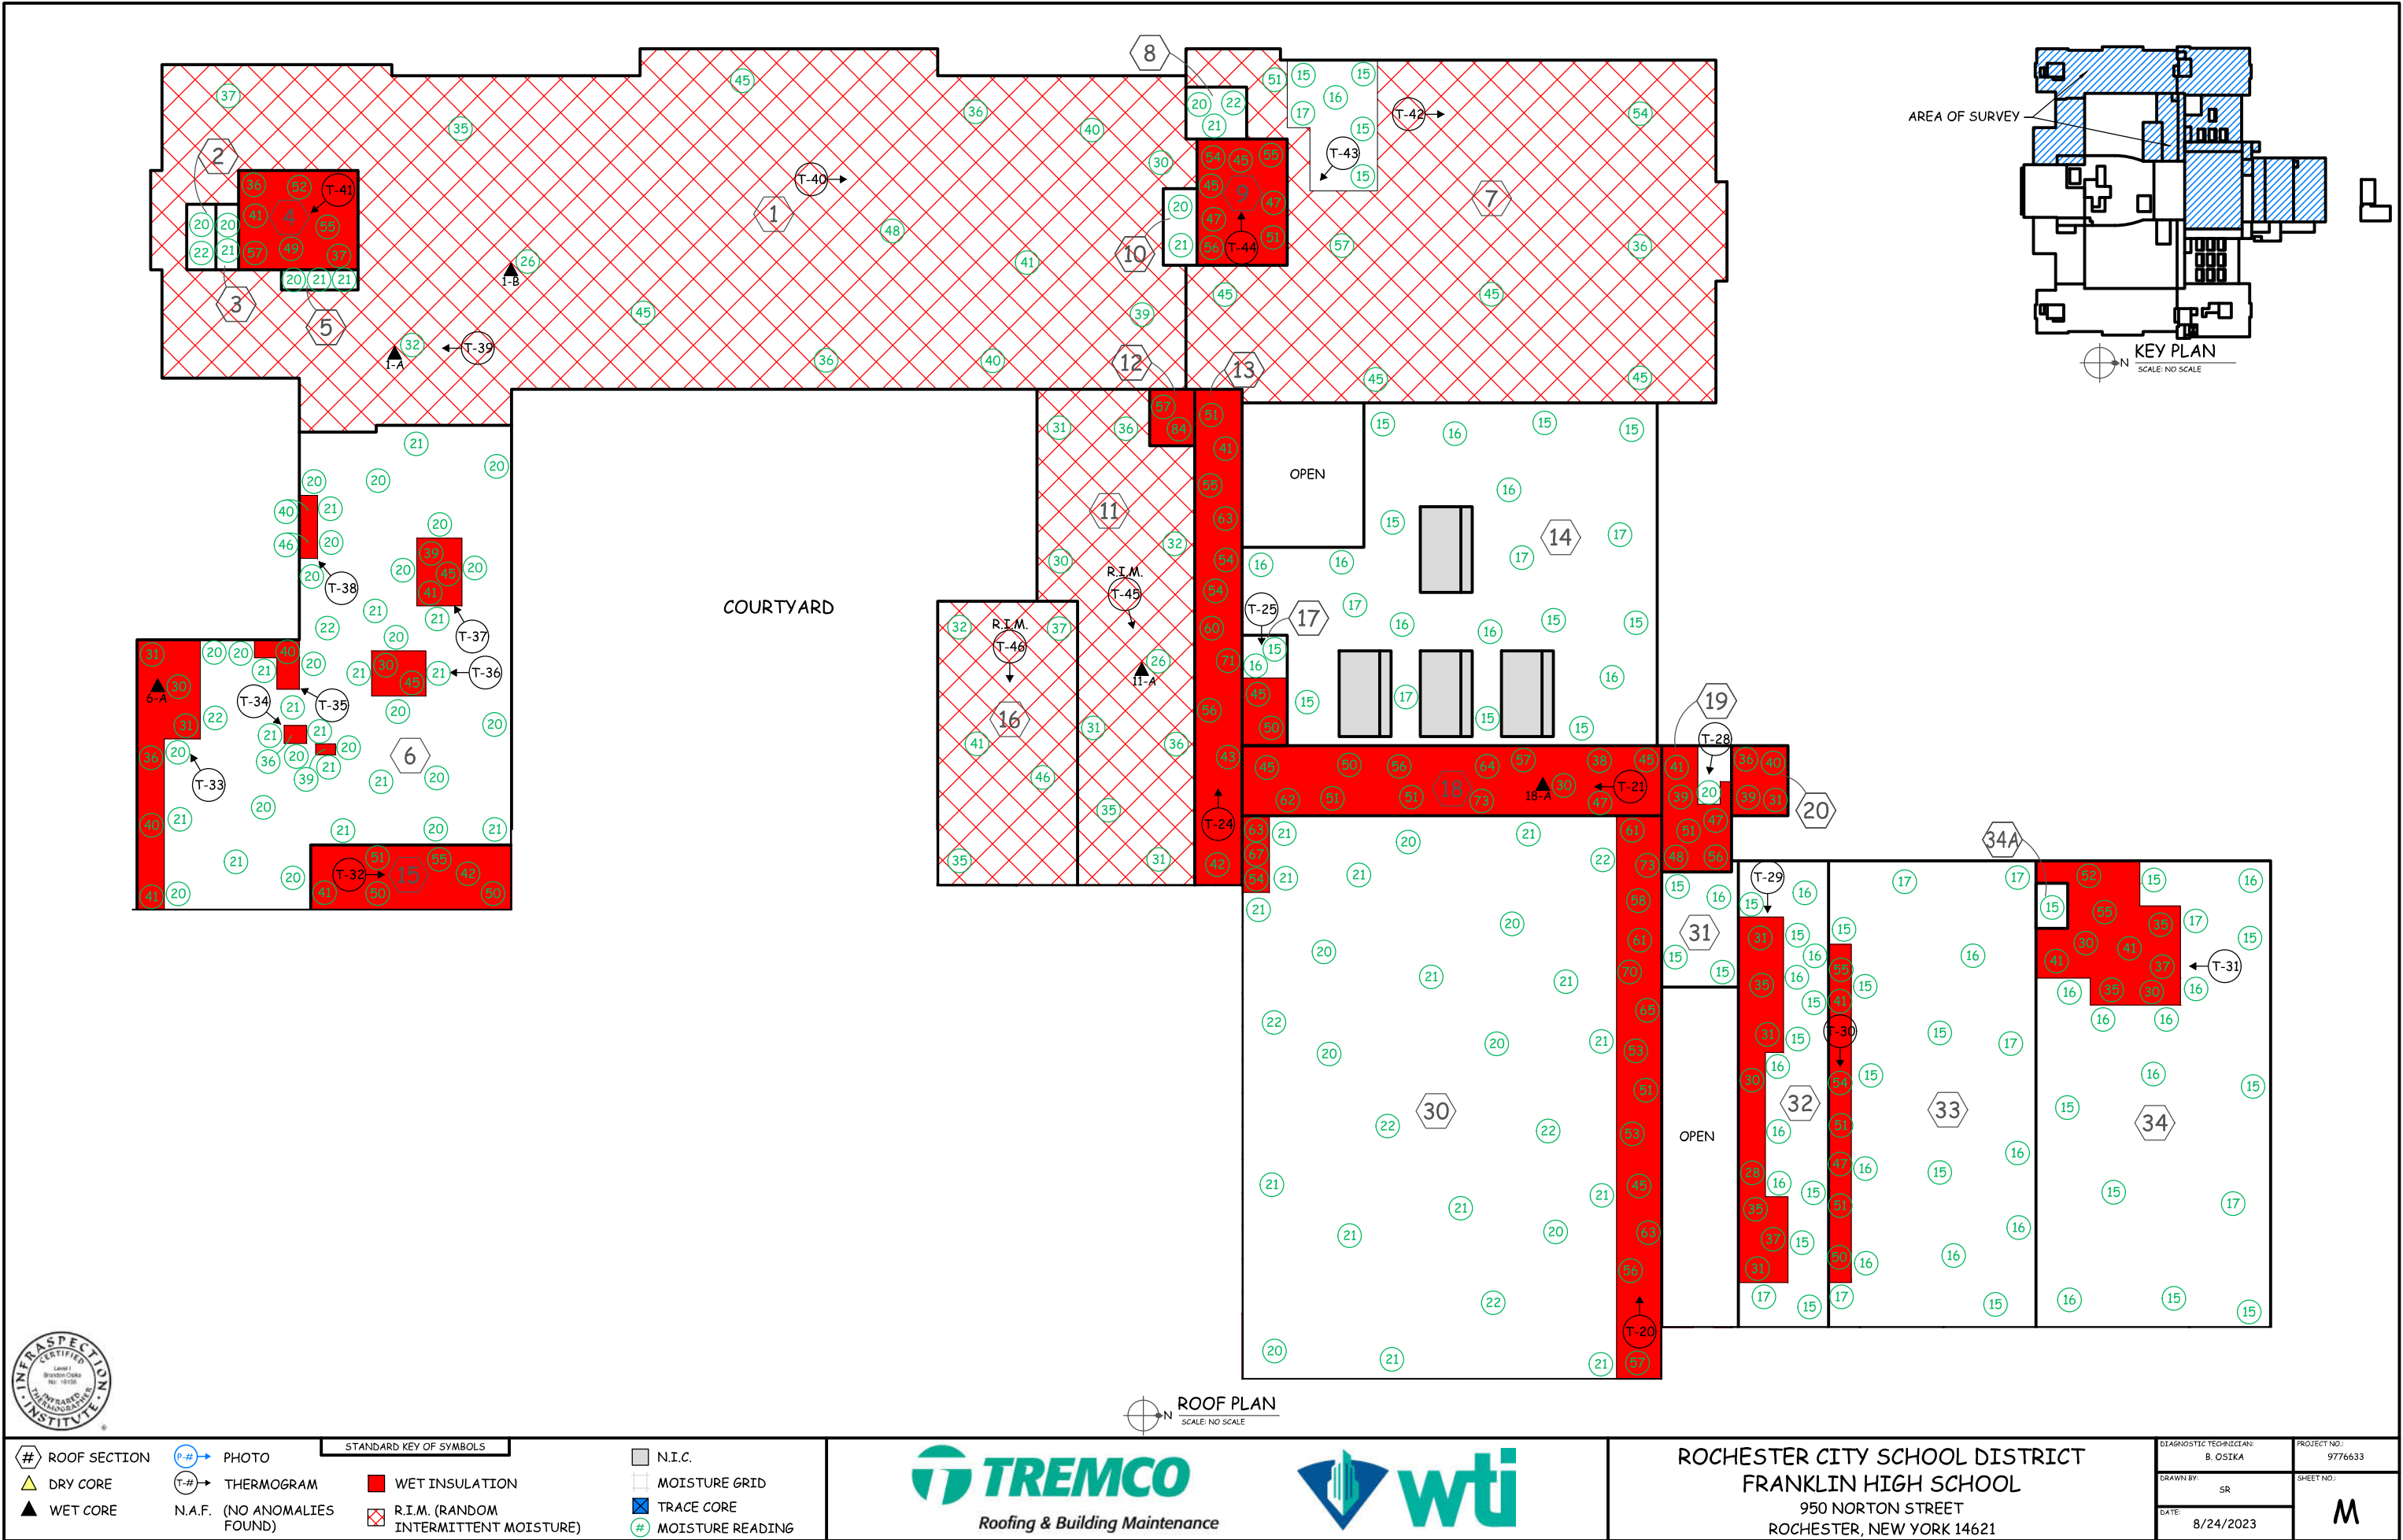
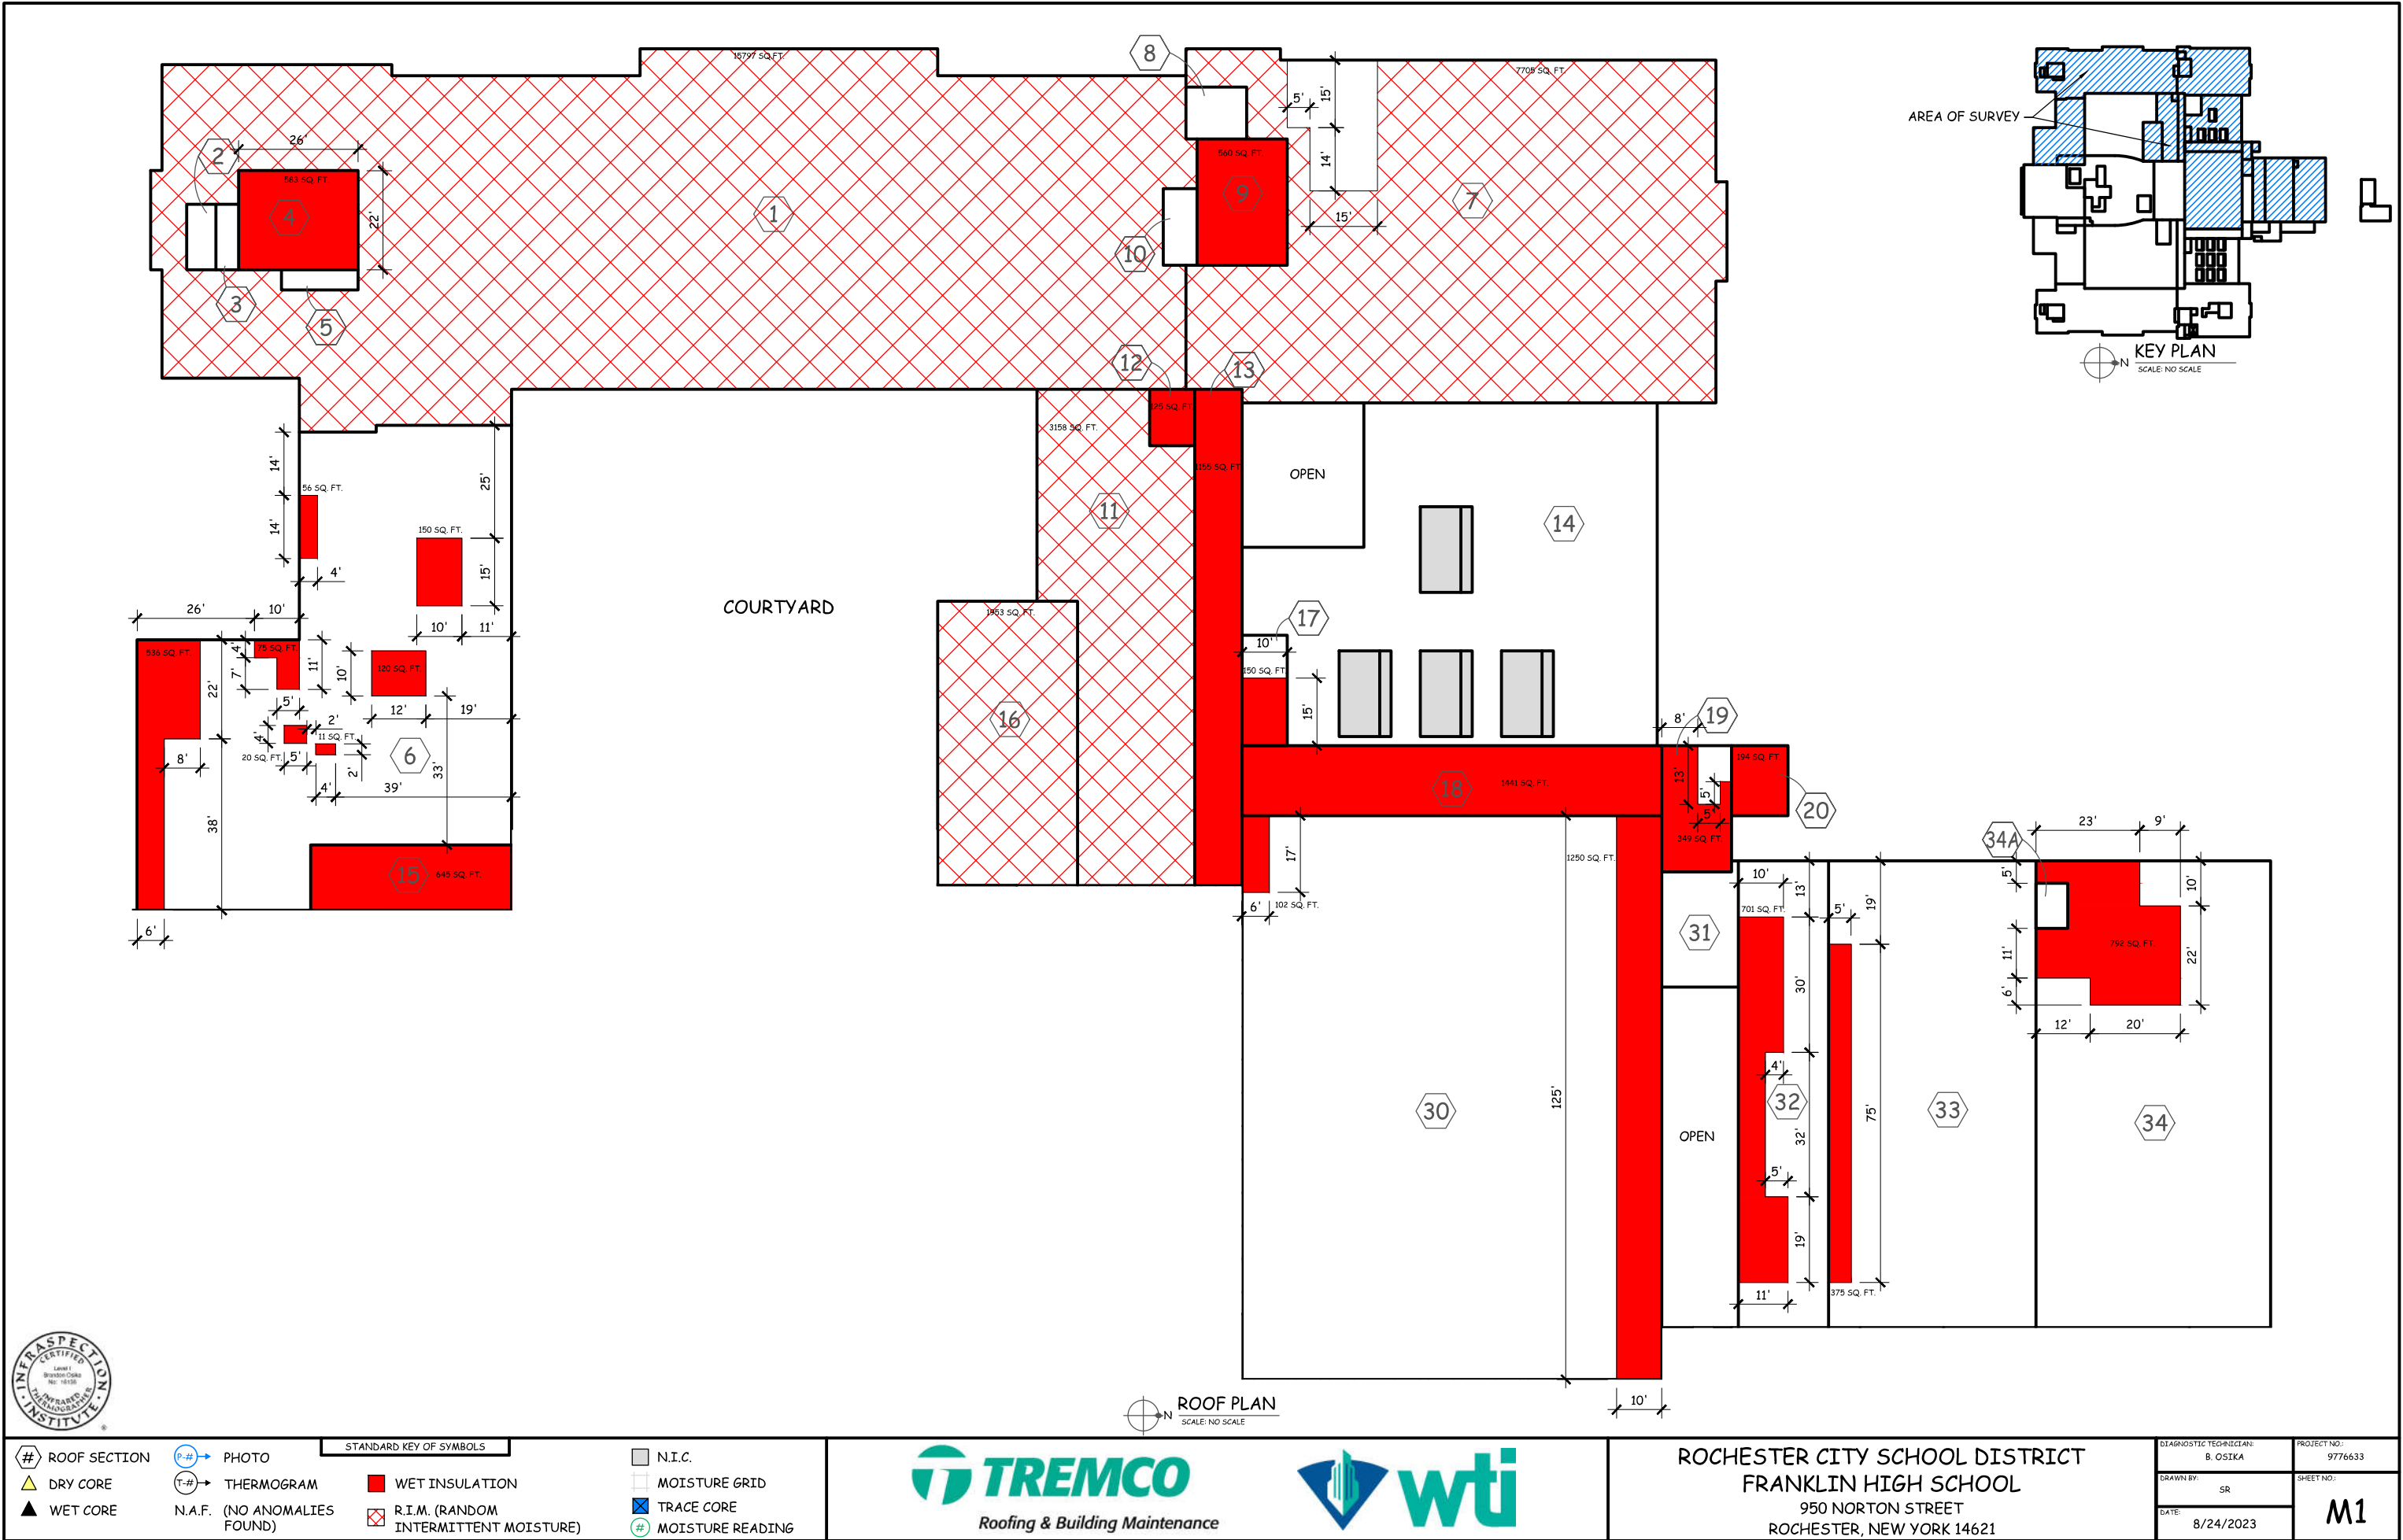
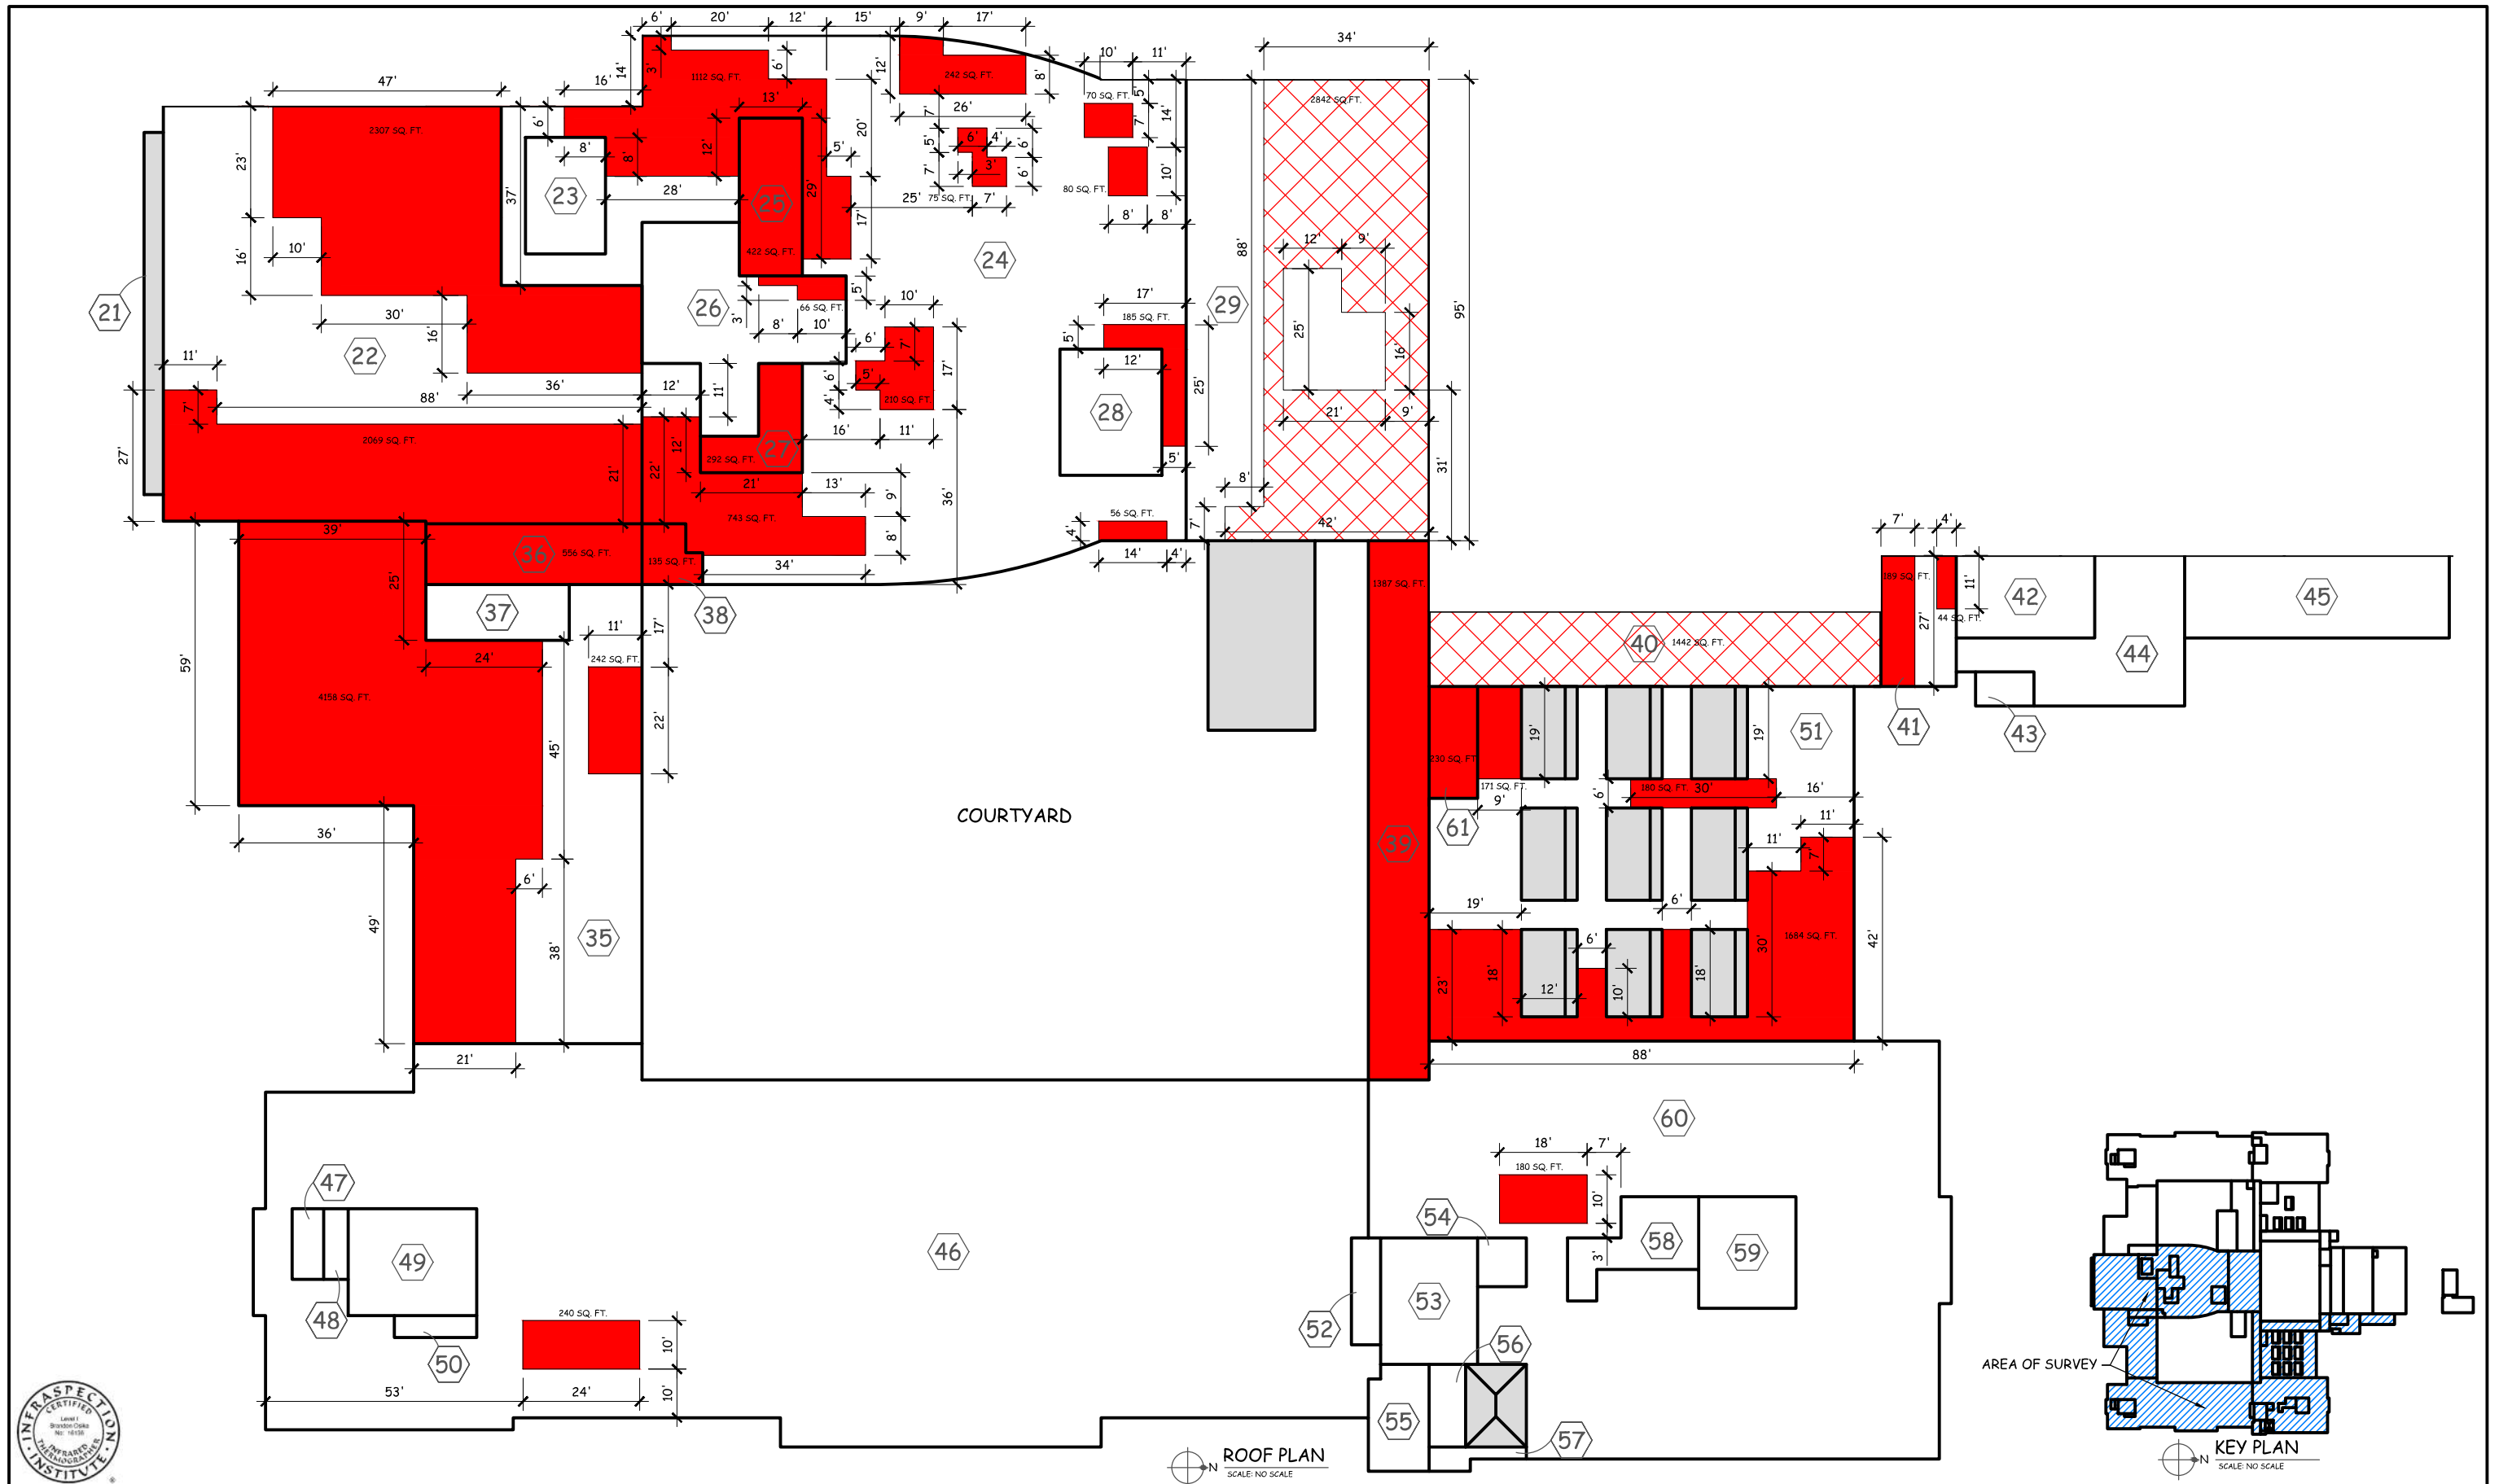
Thermal radiation scans taken from the roof of Franklin Education Campus, are provided in Attachment #1 (below). These were captured in August 2023.

ROOF SECTION DATA			
ROOF SECTION	SIZE (S.F.)	WET (S.F.)	% WET
1	15,797	15,797	100.00%
2	95	0	0.00%
3	73	0	0.00%
4	583	583	100.00%
5	77	0	0.00%
6	6,542	968	14.80%
7	8,215	7,705	93.79%
8	156	0	0.00%
9	560	560	100.00%
10	128	0	0.00%
11	3,158	3,158	100.00%
12	125	125	100.00%
13	1,155	1,155	100.00%
14	5,009	0	0.00%
15	645	645	100.00%
16	1,953	1,953	100.00%
17	245	150	61.22%
18	1,441	1,441	100.00%
19	434	349	80.41%
20	194	194	100.00%
22	7,374	4,376	59.34%

ROOF SECTION DATA			
ROOF SECTION	SIZE (S.F.)	WET (S.F.)	% WET
23	396	0	0.00%
24	10,194	2,773	27.20%
25	422	422	100.00%
26	1,156	66	5.71%
27	292	292	100.00%
28	546	0	0.00%
29	4,750	2,842	59.83%
30	11,625	1,352	11.63%
31	438	0	0.00%
32	2,070	701	33.86%
33	4,752	375	7.89%
34	5,312	792	14.91%
34A	70	0	0.00%
35	6,241	4,400	70.50%
36	556	556	100.00%
37	340	0	0.00%
38	135	135	100.00%
39	1,387	1,387	100.00%
40	1,442	1,442	100.00%
41	419	233	55.61%
42	485	0	0.00%
43	84	0	0.00%
44	861	0	0.00%
45	927	0	0.00%
46	15,745	240	1.52%
47	95	0	0.00%
48	73	0	0.00%
49	583	0	0.00%
50	77	0	0.00%
51	4,446	2,035	45.77%
52	132	0	0.00%
53	520	0	0.00%
54	100	0	0.00%
55	268	0	0.00%
56	128	0	0.00%
57	72	0	0.00%
58	351	0	0.00%
59	460	0	0.00%
60	7,931	180	2.27%
61	230	230	100.00%
TOTALS	140,070	59,612	42.56%
