Program Biograph:  
Frederick Douglass Campus

Frederick Douglass Campus (city-wide)

PHASE III STRATEGIC PLAN  
Rochester School Modernization Program

940 Fernwood Park, Rochester, NY 14609

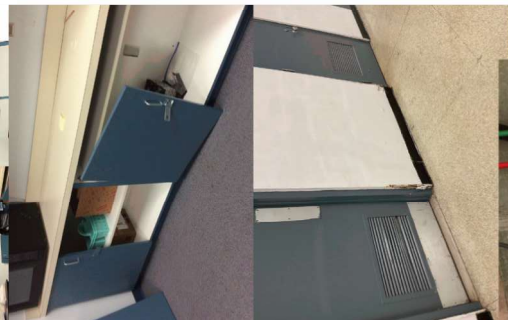
| Rochester City School District | | | Douglass Campus | | | DRAFT | | | | |
|---|---|---|---|---|---|---|---|---|---|---|
| 05B Building Interior EDU | 007 Interior Millwork/Casework | D146A - damaged millwork | | | \$ 6,750.00 | Assumes 10 lf | General Trades | Open | replace millwork | |

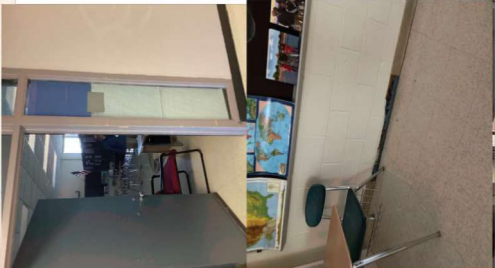
| SWBR Category | NYSED Category | Description | Priority | Cost | Trophy Point Cost | Trophy Point Comments | Contractor Type | Status | Notes | Photo |
|---|---|---|---|---|---|---|---|---|---|---|
| 05A Building Interior BCS | 082 Interior Doors | C190 - wire glass in sidelight | | | \$ 1,000.00 | Assume replace wire glass | General Trades | Open | | |
