# **OLMSTED ENVIRONMENTAL SERVICES, INC.**

Subject: **Ventilation Screening**  
**Abraham Lincoln School No. 22**  
**595 Upper Falls Blvd, Rochester, NY 14605**

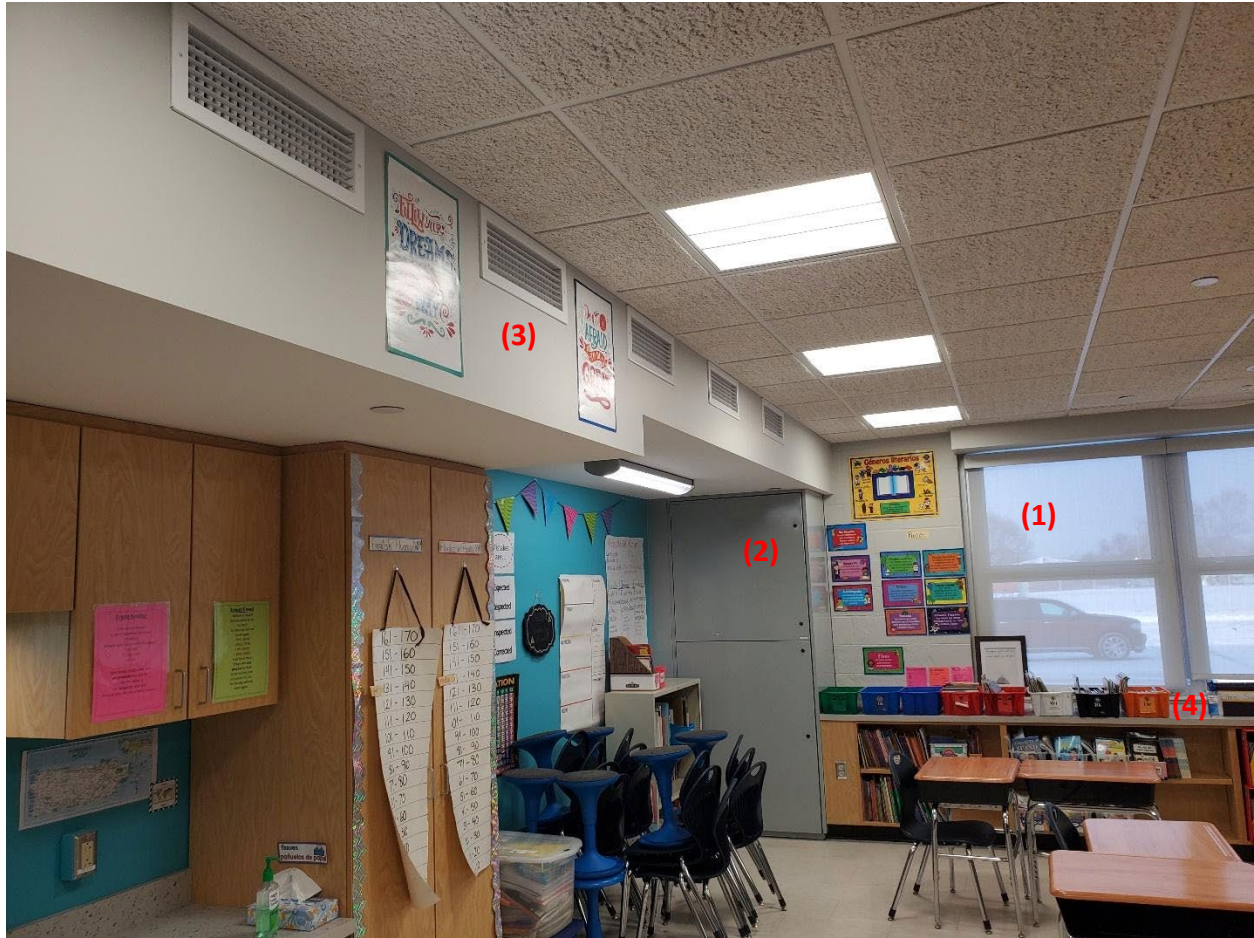
Typical ventilation scheme in classrooms with (1) operable windows, (2) vertical unit ventilator, (3) supply grilles, and (4) return intakes.

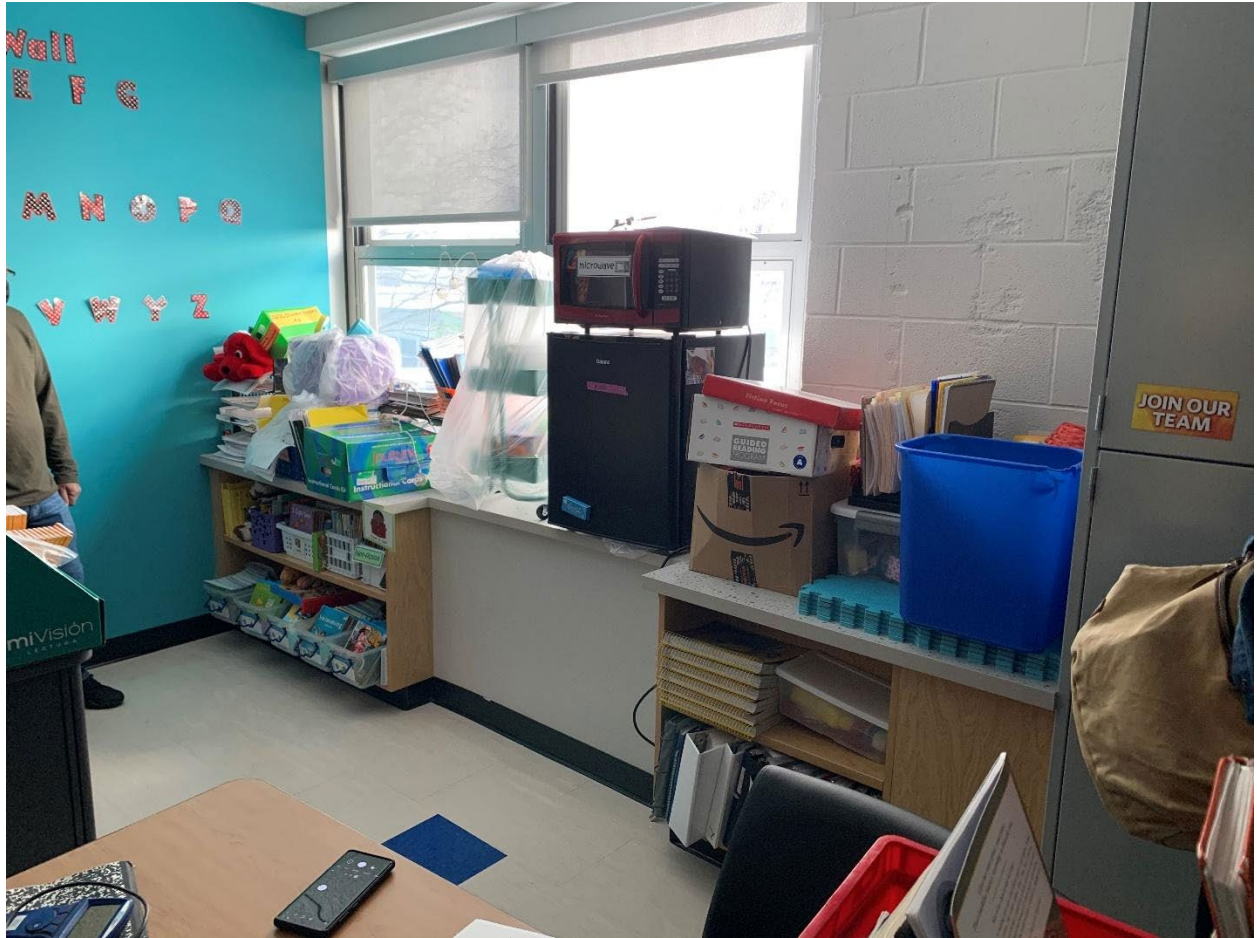
2. Classrooms and offices spaces visited included Rooms 95, 105, 132, 138, the nurse's office, 206 and 207B. The univents in all these rooms were all operational. But it was noted that in multiple rooms, the returns on top of the shelving units by the windows were cluttered with stored materials. This will impede the ventilation rates in those impacted rooms.

Item stored on top of return intake

- 1) The univents should be run continuously when the classroom is occupied. In addition, pedagogical staff should not tamper with the univent to turn them off, instead consult the building engineer to address excess temperatures.
- 2) Do not block return intakes located on the tops of the shelving units by the windows and keep the VUV clear of excess stored materials.
- 3) The univents provide outside air in most classrooms. However, where possible and if necessary, teachers can open two windows in each room to an opening of two inches. This will provide natural ventilation without causing the room to become cold.
- 4) Install MERV 13 filter in the VUVs as soon as they arrive.

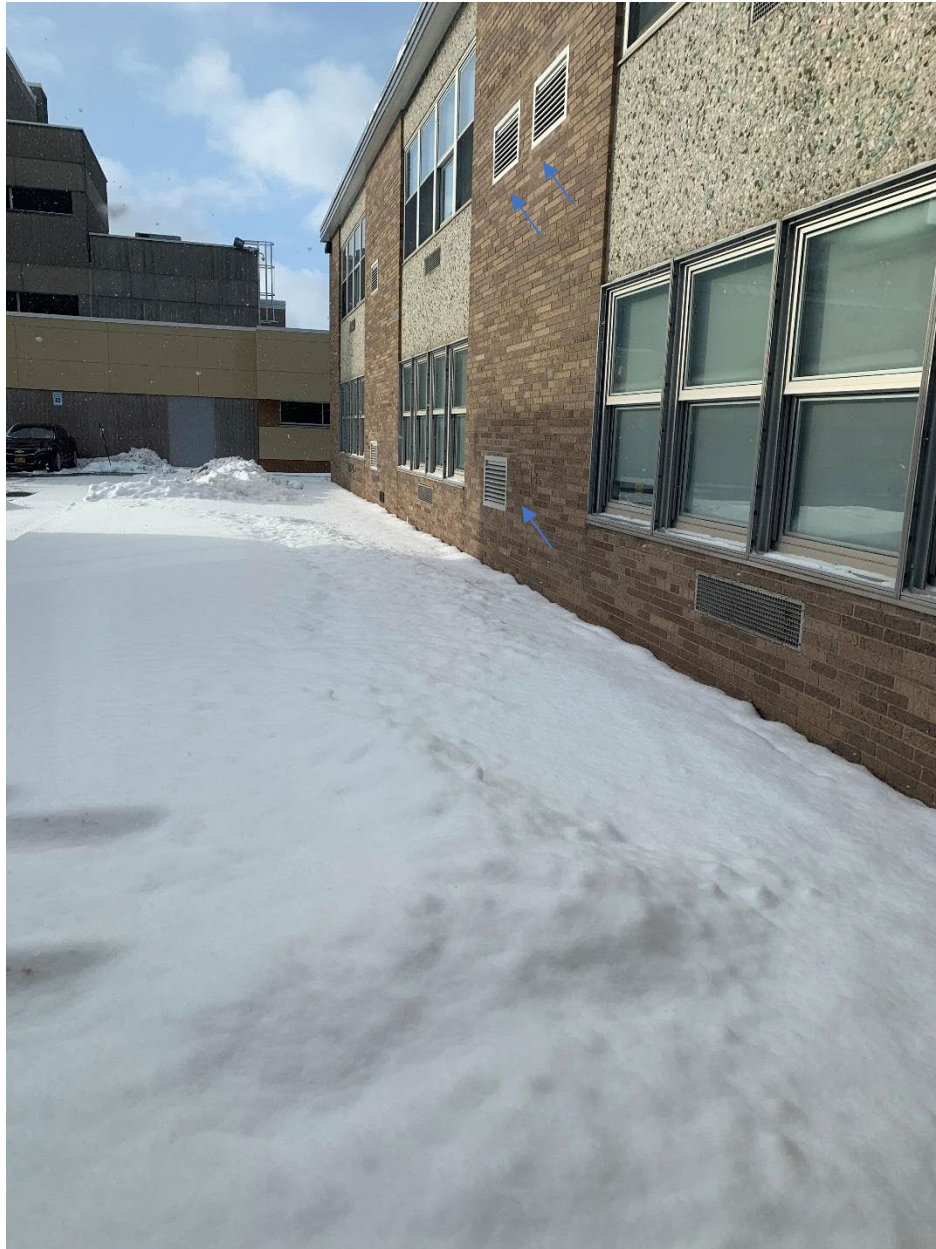
Exterior outside intake grilles seen underneath the windows

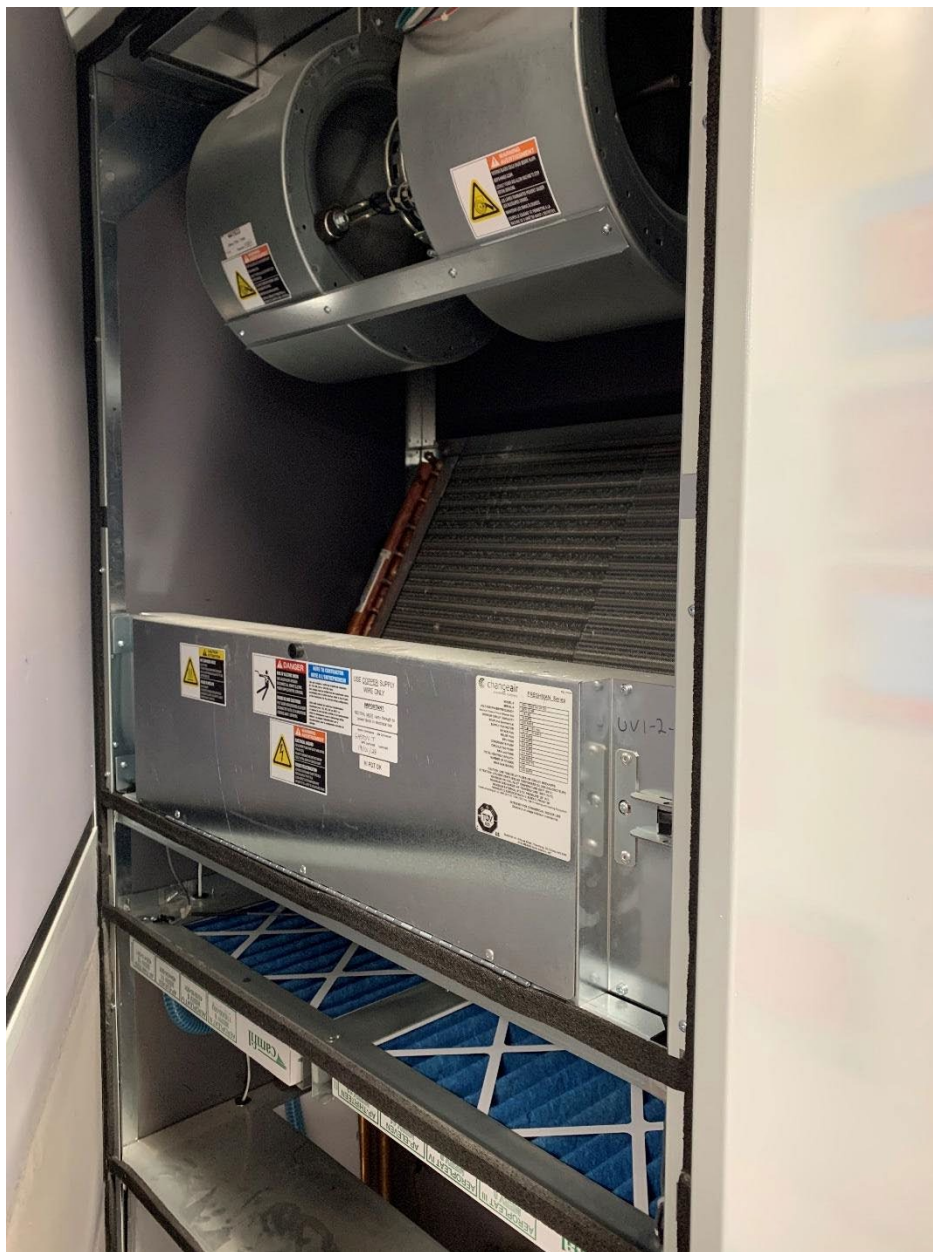
1. School No. 2 has a combination of ventilation methods.
  - a. Most classrooms and offices are served by vertical unit ventilators (VUV). They appear as large gray units in the corner of the room. One unit can serve two neighboring rooms. These univents are standalone units that have heating coils and outside air inlet. The units draw return air through grilles located on the shelving unit at the base of the windows and also draws outside air through a sleeve that penetrates through the wall to the outside. That outside air is heated and filtered before it is delivered into the room usually at grilles located at a ceiling soffit near the unit. The outside air grille can be viewed typically outside the building under the windows. The VUVs currently utilizes MERV 8 filters and RSCD Facilities is waiting for additional shipments of MERV-13 filters.

Inside a VUV. Note the MERV 8 (blue) filter.

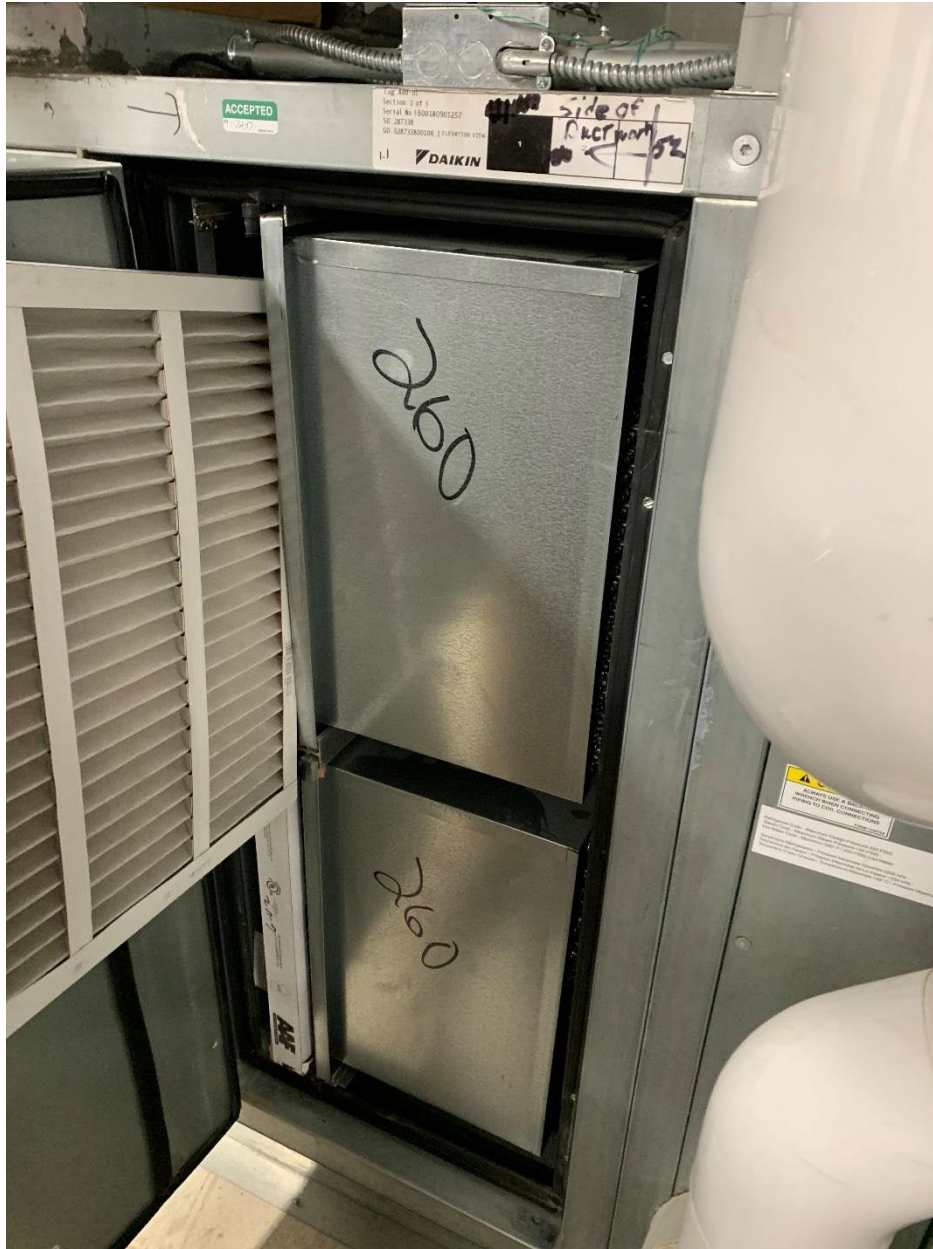
- b. Rooms such as larger public assembly spaces that do not have a dedicated VUV are served by air handler units. These air handler units were fairly new and in good shape. It was noted to have been fitted with MERV 8 pre-filters and MERV-13 or higher filters.

Areas not served by a VUV are served by air handler units. This is the filter bank for an AHU and is typical of the units in the building. They include MERV 8 pre-filters in front of MERV 13 or higher box filters.
