# **OLMSTED ENVIRONMENTAL SERVICES, INC.**

Subject: **Ventilation System Screening**  
**School 52 – Frank Fowler Dowd School, 100 Farmington Rd., Rochester, NY**

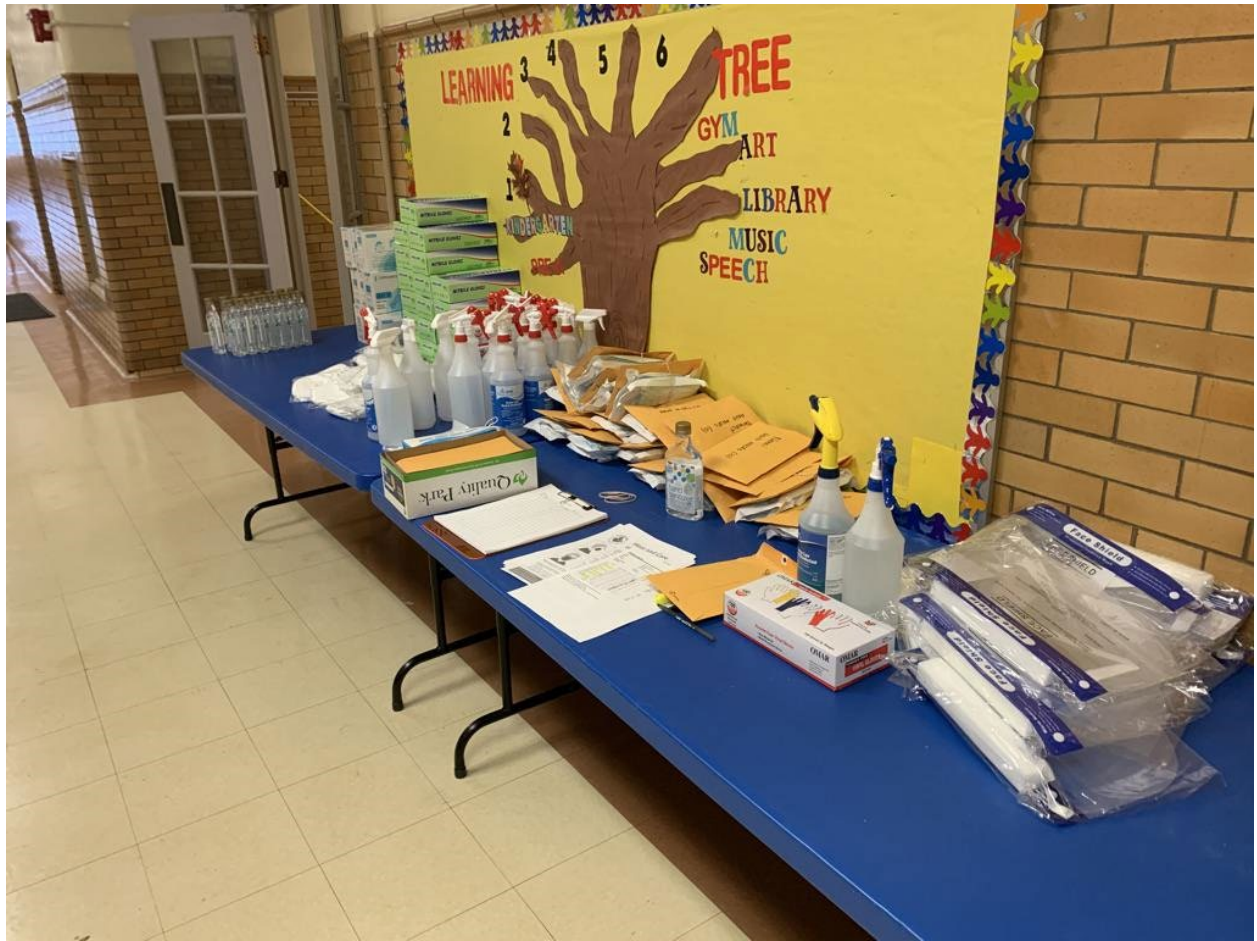
Cleaning materials, PPE and other COVID related supplies

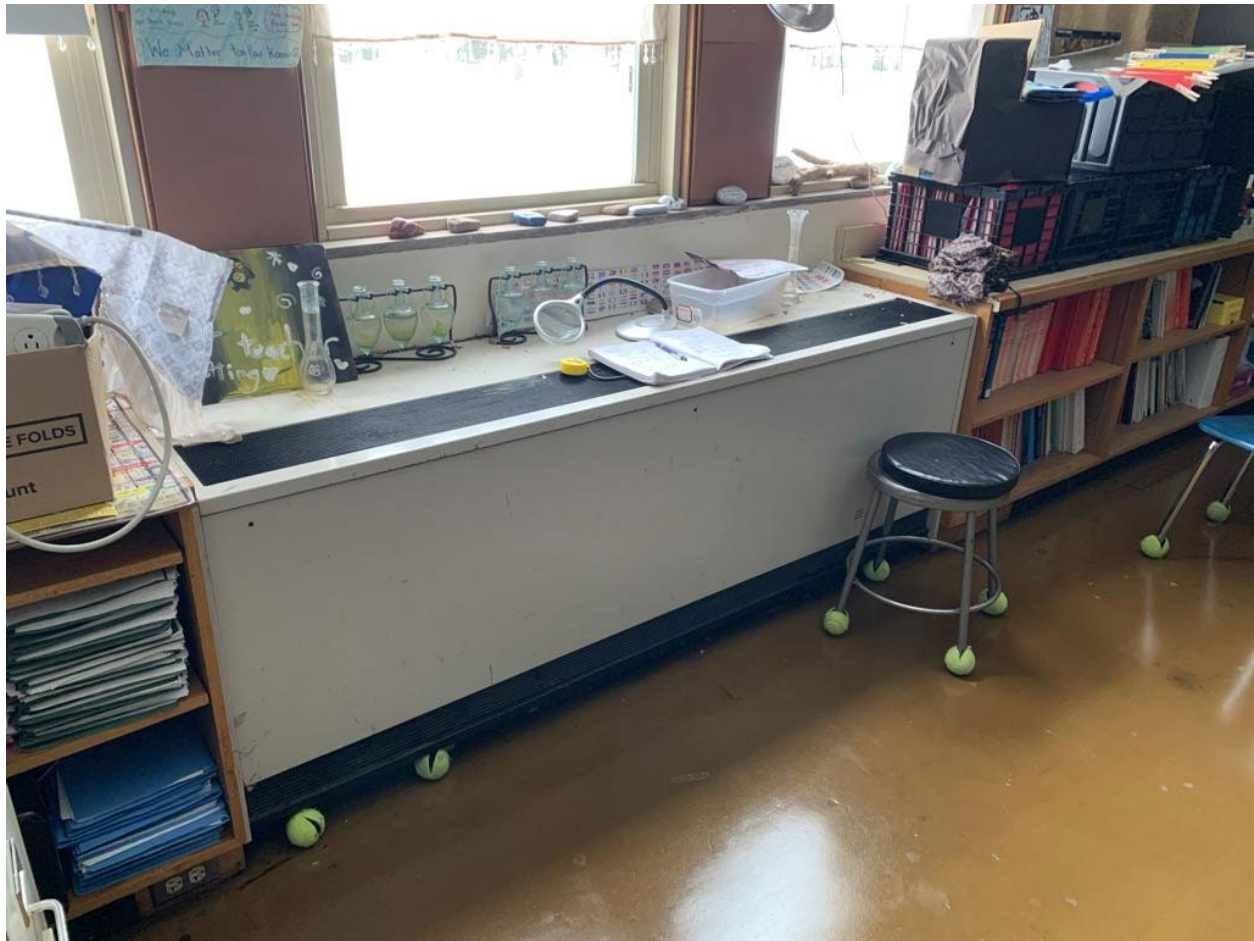
School is heated and ventilated by univents that provide outside air  
The windows can be opened for natural ventilation

1. School 52 was renovated and the interior is of modern construction. The school building has a masonry exterior and is of concrete and steel construction. The building is served by univents in each classroom that provide a mixture of outside air and room air. The univents have a heating coil and filters are rated at MERV 13.

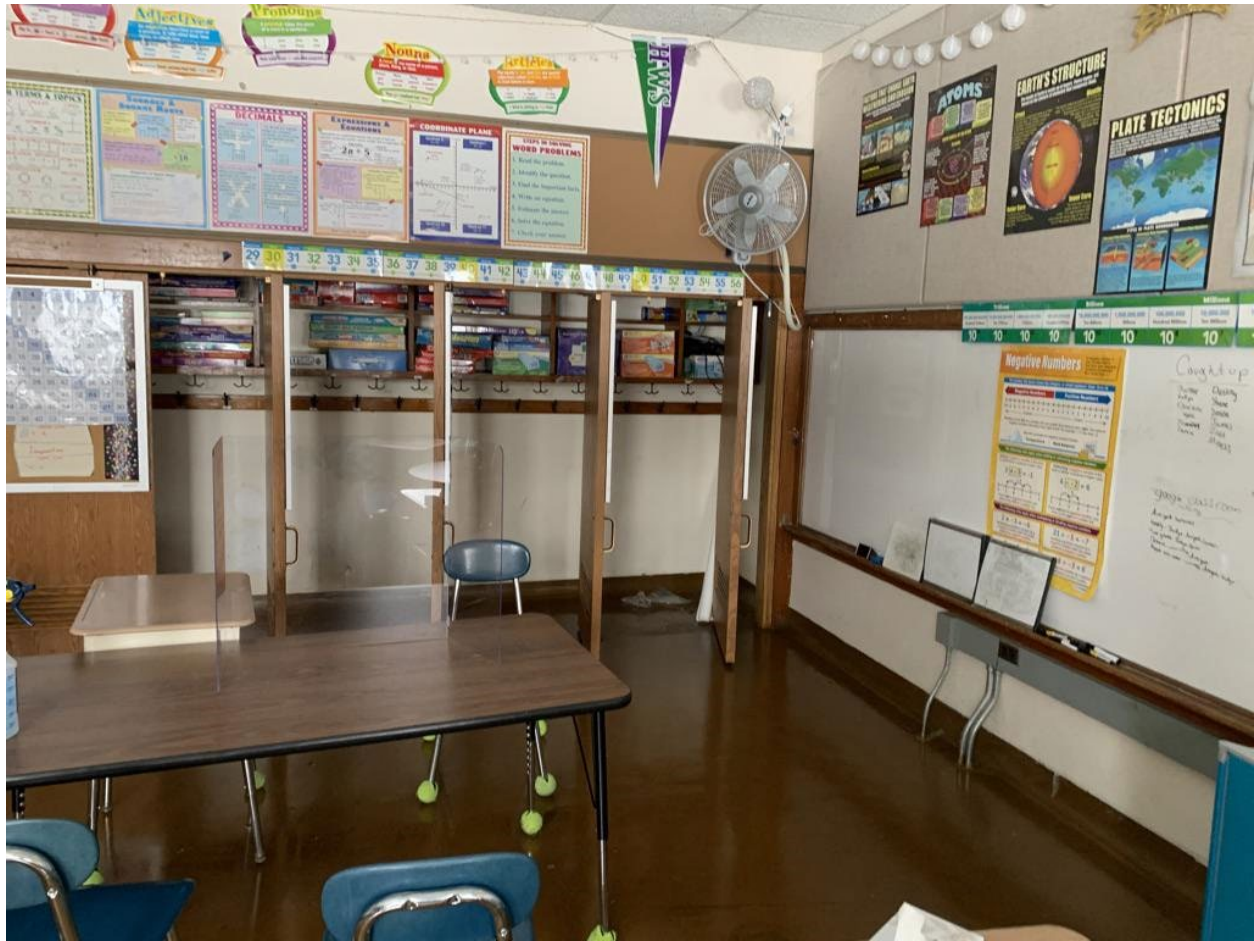
Vents in closet provide natural exhaust ventilation

2. The rooms are also heated by perimeter steam radiators.
3. There are exhaust fans on the roof that pull air from the bathrooms, which are located in many of the classrooms. Each classroom has operable windows that can be opened for outside air. There are gravity (passive) vents in the coat closets in each classroom that allow for natural exhaust of air to the roof. Air flows to the roof from the classrooms by stack effect and thermal effects and also to relieve pressure from the univent mechanical supply of outside air.
